CFD simulation of multiple dust explosion occurred in a flour mill

CFD simulation of multiple dust explosion occurred in a flour mill / Russo, Patrizia; Tabib, Achraf; Mazzaro, M.; Danzi, E.; Marmo, L.. - In: CHEMICAL ENGINEERING TRANSACTIONS. - ISSN 2283-9216. - ELETTRONICO. - 77:(2019), pp. 865-870. [10.3303/CET1977145]

## CFD Simulation of Multiple Dust Explosion Occurred in a Flour Mill

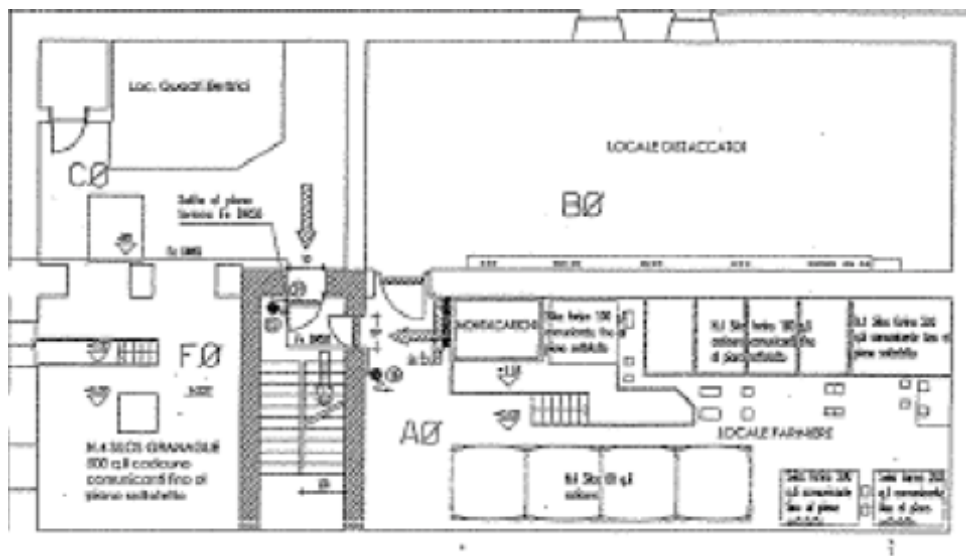
Figure 1. Plan of the basement of the main building.

In Figure 1, A and B are the areas of the main building of the mill which underwent a considerable, but not complete, collapse.

In the basement, the collapse of all the B rooms and of their equipment occurred. Most of the equipment (i.e. plansichters, mills, cyclones, cochlea and elevator ducts) was not burned by the fire. With regards to the walls, the north one collapsed, but the internal ones were only damaged. Also, the stability of internal staircase, which was found in its original position, was compromised.

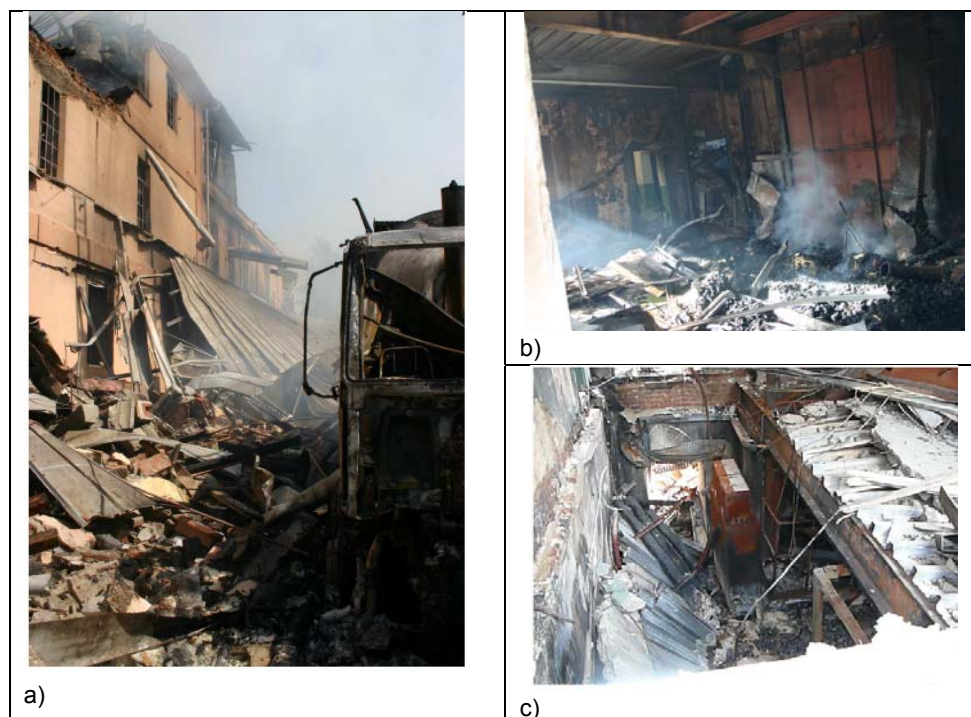
On the contrary, in the A area of the basement the walls and equipment were primary damaged by the fire, which had burned over a long period of time (Figure 2). The internal overpressure caused damage to the ceiling of A0 area as well as that of the A1 area (Figure 2). The hoist bay was destroyed by internal overpressure, while the overpressure from the hoist caused major damage to the structures on the side of the building.

The roof above north and south wings was torn away and projected at a considerable distance. Debris launch distance is much higher toward south than toward north as the rooms on the A side were certainly affected by a strong internal overpressure of intensity depending on the altitude, which caused obvious projections of the structures and debris towards the outside and upwards. On the contrary, the rooms B were mainly affected by a static collapse that has caused the collapse of the structure and the machines: in fact, most of the rubble is located within the perimeter or very short distance. All the other rooms were marginally affected by the explosion, while some, like the sacks warehouse, suffered from the long fire that followed the explosion.

Figure 2. Damage of the main building from the exterior (a) and inside the A area (b,c).

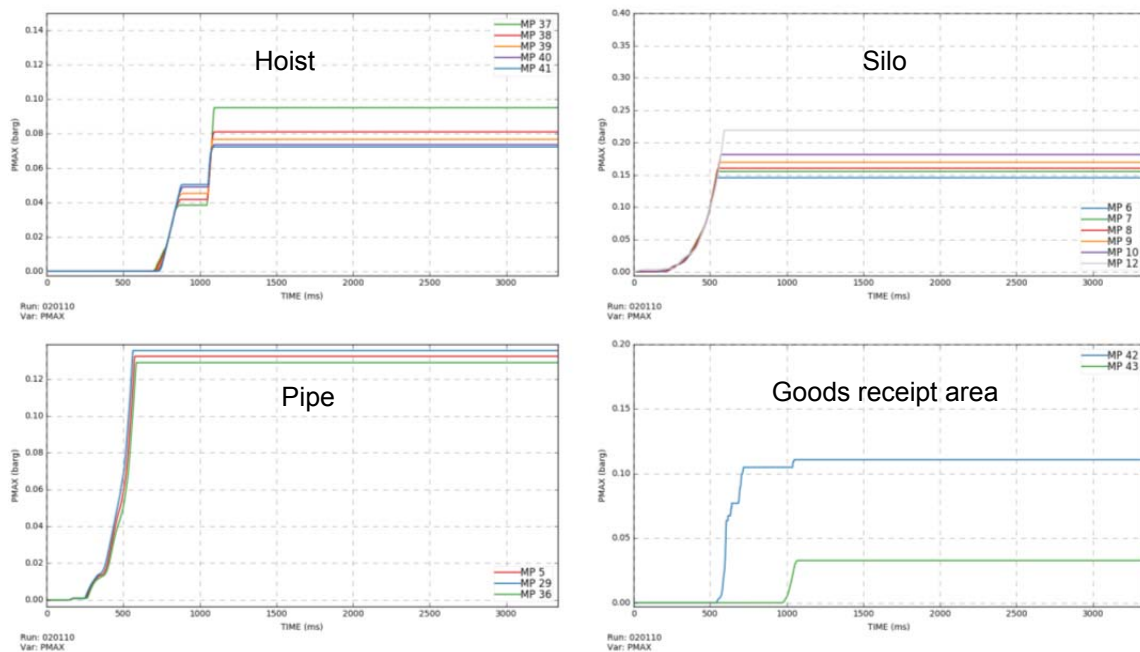
Simulations were performed for various scenarios with different levels of flour in the silo, concentration of dust and position of ignition. The overpressures predicted for each scenario in the different monitor points were compared with the failure pressure of the various objects. From the comparison, it was possible to define the scenario that is compatible with the damage observed after the explosion. It corresponds to the scenario with the silo only partial filled with flour (1/3 of volume), concentration of dust in the dust cloud of  $2000 \text{ g/m}^3$  (higher than the stoichiometric value) and the ignition at the top of the silo. Results of the simulations were reported in figure 5 for this scenario. They showed that it can predict: the collapse of the silo, because of the overpressure increase along the silo length from the top ( $P_{\max} = 0.15 \text{ barg}$ ) to the bottom of the silo up the failure value ( $P_{\max} > 0.20 \text{ barg}$ ). Moreover, it can describe the propagation of the blast wave into the pipe and, as consequence of the silo collapse, then in the goods receipt area, where the under-roof and of roof panels fell. The propagation of the blast wave to the hoist, from the top to the bottom, with the collapse of the hoist door ( $P_{\max} > 0.07 \text{ barg}$ ), and then to the basement where overpressure as high as  $0.27 \text{ barg}$  caused the collapse of the concrete floor (Figure 6) and consequently of the flour bins. The large amount of dust dispersed in the area, because of the poor housekeeping, ignited by the blast wave, was then the cause of multiple explosions occurred in the plant.

Figure 5.  $P_{\max}$  vs time in the monitor points located in the hoist, silo, pipe and goods receipt area.
